Flatrock Creek/Auglaize River Watershed Management Plan 2022

Planning for Five HUC 12 Subwatersheds: Wildcat Creek (041000071205); Headwaters Flatrock Creek (041000071201); Bohnke Ditch (041000071203); Hoffman Creek (041000071202); Brown Ditch (041000071204)

Prepared by the Allen County Soil & Water Conservation District and the Flatrock/Auglaize Steering Committee

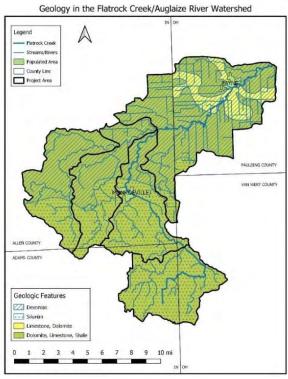
Figure 2.3 Geologic Features in the Flatrock Creek/Auglaize River Watershed

Northeast Indiana and Northwest Ohio's landscape consisted of rolling hills and valleys accompanied by streams and lakes until the Wisconsin glaciation that occurred over 14,000 years ago. Three episodes or lobes: Huron-Erie, Saginaw, and Erie lobe, together made up the Wisconsin glaciation. The Huron-Erie lobe traveled east to west and deposited subsurface bedrock fragments known as the "Trafalgar Formation" which is composed of Ordovician limestone, Silurian dolomite, Devonian limestone and Devonian black shale. The most relevant and recent event, the Erie lobe, created the Lagro Formation which advanced across clay-rich lakes resulting in the clay-rich composition we see today in the landscape. The main parent material of the Lagro formation are fine-grained tills which aid to protect the aquifers in the area. The movement of these massive ice sheets resulted in a homogenous landscape that flattened the hills, filled in preexisting streams, and formed lakes (ex: Great Lakes). Rocks, sand, and minerals were deposited across the terrain as this glacier melted. The predominant bedrock of the project area consists of black shale, shale, dolomite and limestone. Karsts features are not exposed at the surface and are buried. (Figure 2.3)

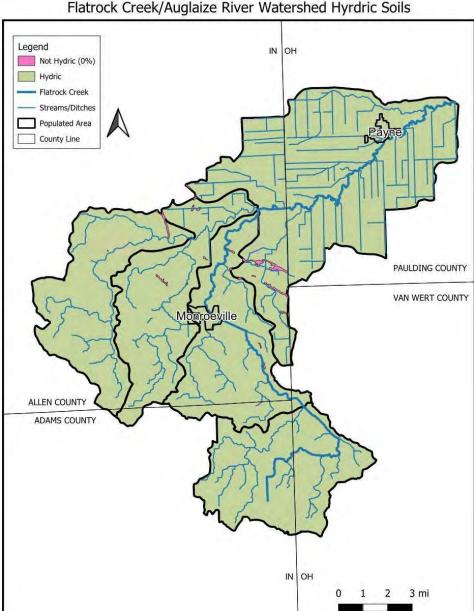
Figure 2.4 Hydric Soils of the Flatrock Creek Watershed

Soils that are saturated or inundated with water for extended periods of time are classified as hydric. Figure 2.4 shows the extent of hydric soils in the project area. Approximately 94,816 acres, or 98% of the Flatrock Creek watershed soil types are classified as hydric.

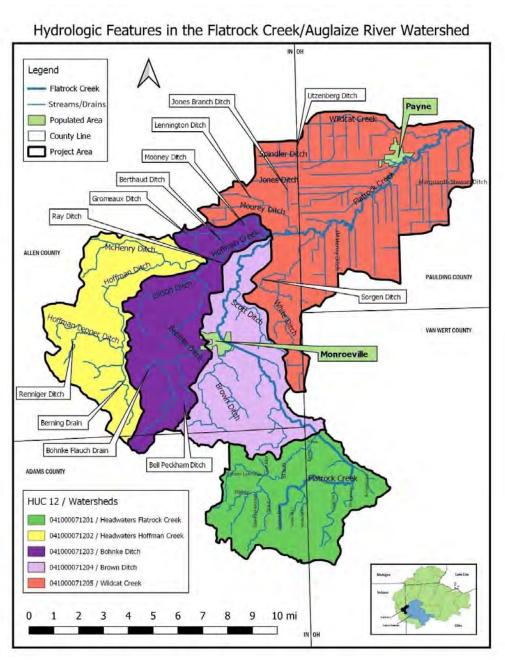
Figure 2.5 Hydrologic Features in the Flatrock watershed

Extensive hydrologic modifications have been made to the natural drainage system. Manmade ditches are common in all of the subwatersheds. Construction began in the early 1800s to drain the Black Swamp and allow agricultural access to the land. Along with the ditches, extensive underground tile drainage systems have been installed in crop fields. In most areas, the ditches and main-line tiles are maintained by local county drainage boards. Field drainage tiles are maintained privately. There are no natural or manmade dams or lakes in the project area. Figure 2.5 shows the hydrologic features.

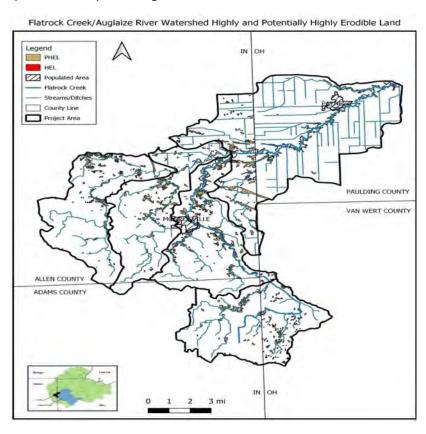
Figure 2.9 Highly erodible soils in the Flatrock Creek watershed

The inventory of highly erodible and potentially highly erodible soils in the project area reveals that 486.2 acres, or 0.50% of the lands within the project area are classified as highly erodible. Potentially highly erodible lands cover 2,592.83 acres, or 2.68% of the project area. (Figure 2.9). The remaining acres in the watershed are classified as non-highly erodible lands. Because the percentage of highly erodible soils is so low, gully erosion is uncommon. Sheet and rill erosion are common in areas where there is little to no plant residue protecting the soil.

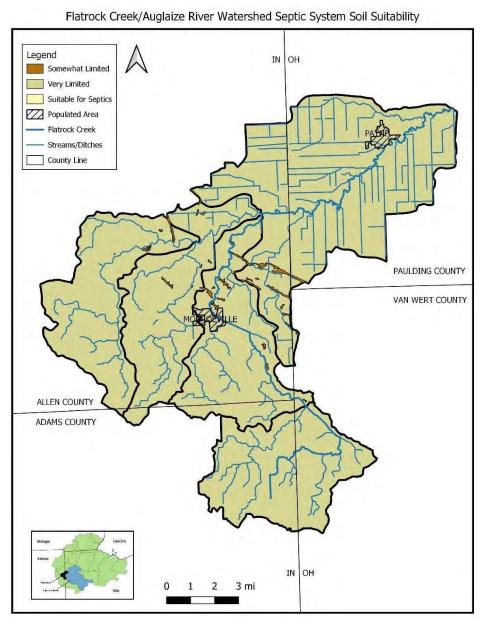
Figure 2.11 Septic System Soil Suitability

In the county Soil Surveys, soils are classified for their ability to function as septic disposal fields. The classifications are: Suitable for Septics; Somewhat Limited - possible contamination of water sources; and Very Limited - likely contamination of water sources. Figure 2.11 shows the extent of these characteristics in the Flatrock Creek watershed. 99.7% (96,305 acres) of the Flatrock watershed is considered "very limited" in terms of soil suitability for septic systems. The remaining 0.03% (275 acres) are classified as "somewhat suitable". No "suitable" acres for septic use were found.

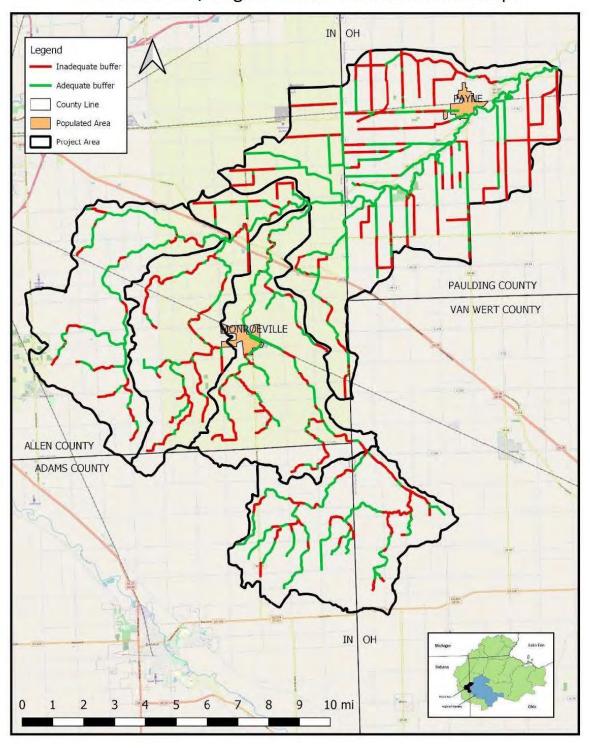
Figure 2.14 Filter Strip Inventory for Entire Project Area

A desktop filter strip inventory was completed for the entire project area using Google Earth 3D. For each subwatershed, reviewers began downstream and worked their way up the mainstem and tributaries noting the condition of the riparian corridor as it relates to adequate vegetation serving as a filter strip. "Adequate" was determined to be 20 feet of width or greater. Adequate filter strips have the potential to stabilize banks and intercept nutrients and sediment in surface water runoff. Figure 2.14 represents the inventory for the entire project area. A comprehensive evaluation of the filter strip inventory results is presented in Section Three on a subwatershed basis.

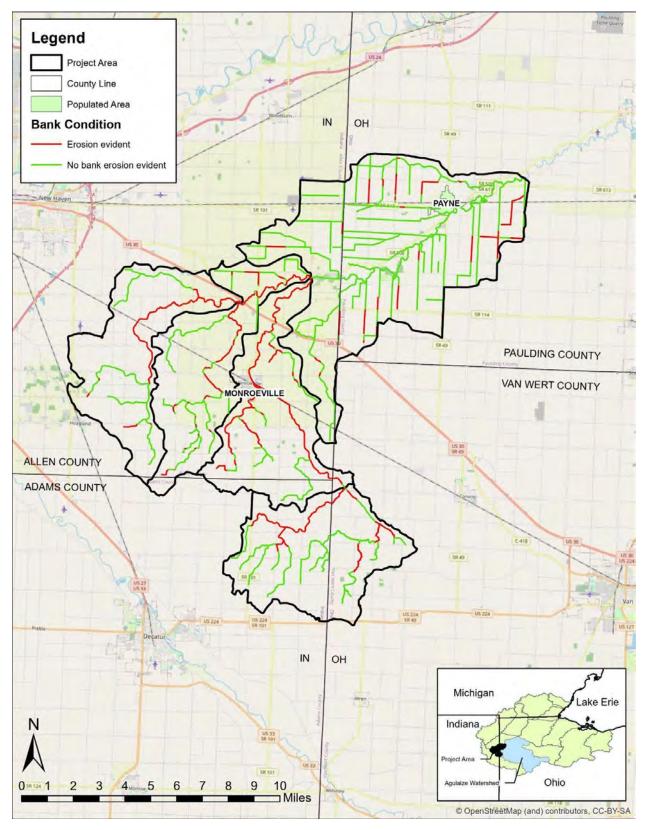
Figure 2.16 Project Area Bank Erosion Inventory, looking downstream

A desktop inventory of eroded stream and ditch banks was conducted alongside the filter strip inventory using Google Earth 3D. Areas where reviewers could see bank erosion were noted on maps. In the project area; 46.3 miles of streams have bank erosion on both sides, 10.3 miles have bank erosion on the left side when looking downstream, 15 miles of streams have bank erosion on the right side when looking downstream, and 217 miles of streams do not exhibit signs of bank erosion. Figure 2.15 represents this information in percentages of the total and Figure 2.16 provides a visual representation of the inventory.

The desktop filter strip inventory conducted for Bohnke Ditch shows that 5.7 miles of streams have bank erosion on both sides, 1.7 miles have bank erosion on the left side when looking downstream, 4 miles of streams have bank erosion on the right side when looking downstream, and 22 miles of streams do not exhibit signs of bank erosion. Figure 2.27 represents this information in percentages of the total and Figure 2.16 shows the inventory locations.

The desktop filter strip inventory conducted for Brown Ditch shows that 13.7 miles of streams have bank erosion on both sides, 1.4 miles have bank erosion on the left side when looking downstream, 4.8 miles of streams have bank erosion on the right side when looking downstream, and 11 miles of streams do not exhibit signs of bank erosion. Figure 2.32 represents this information in percentages of the total. Figure 2.16 shows the inventory locations.

The desktop filter strip inventory conducted for Headwaters Flatrock Ditch subwatershed shows that 10.2 miles of streams have bank erosion on both sides, 0.4 miles have bank erosion on the left side when looking downstream, 0.4 miles have bank erosion on the right side when looking downstream, and 22.3 miles do not exhibit signs of bank erosion. Figure 2.37 represents this information in percentages of the total and Figure 2.16 shows the inventory locations.

The desktop filter strip inventory conducted for Headwaters Hoffman Ditch subwatershed shows that 8.9 miles of streams have bank erosion on both sides, 0.2 miles have bank erosion on the left side when looking downstream, 0.5 miles have bank erosion on the right side when looking downstream, and 14.3 miles do not exhibit signs of bank erosion. Figure 2.42 represents this information in percentages of the total. Figure 2.16 shows the inventory locations.

The desktop bank erosion inventory conducted for Wildcat Creek subwatershed shows that 7.8 miles of streams have bank erosion on both sides, 6.7 miles have bank erosion on the left side when looking downstream, 5.4 miles have bank erosion on the right side when looking downstream, and 146.8 miles do not exhibit signs of bank erosion. Figure 2.47 represents this information in percentages of the total and Figure 2.16 shows the inventory locations.

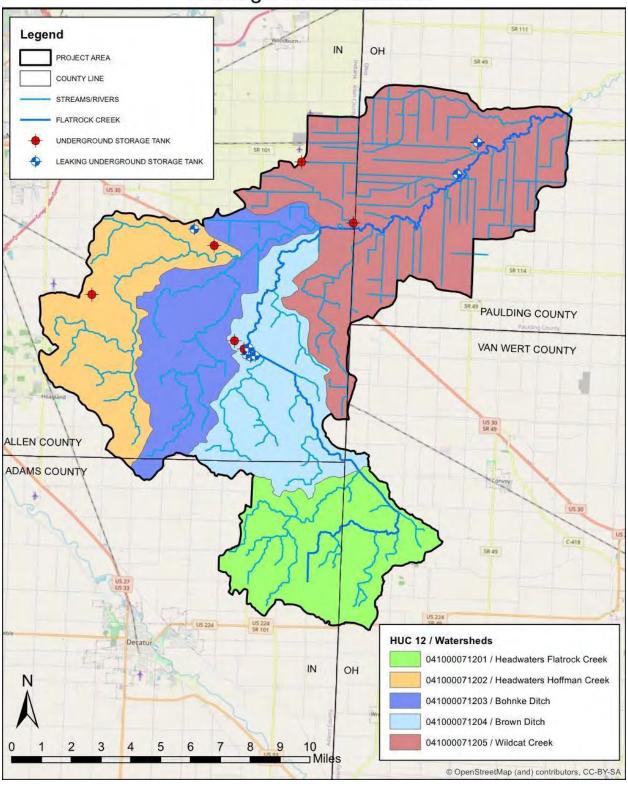
Figure 2.19 Underground Storage Tanks

In total, seven USTs and seven LUSTs are within the project area. Locations of USTs and LUSTs are provided in Figure 2.19. Both the Bohnke Ditch HUC-12 and Headwaters Flatrock Creek HUC-12 are absent from UST systems. Brown Ditch contains seven, five of which are leaking. The Wildcat Creek HUC-12 contains four (one leaking), and Headwaters Hoffman Ditch HUC-12 contains three (one leaking).

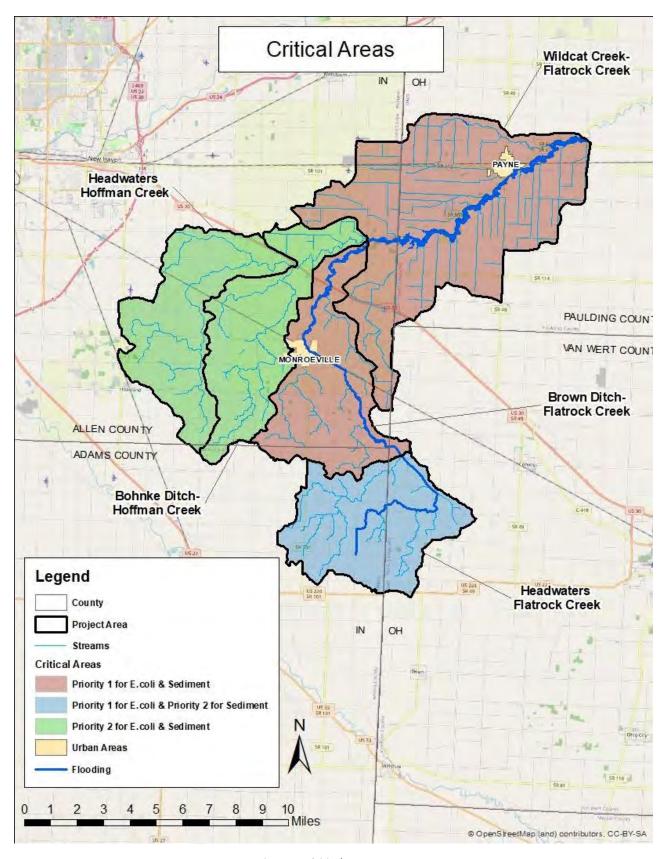
Figure 4.1 Critical areas map

Critical areas for urban land uses were determined using the land use inventory and windshield survey data and are identified as: all municipalities in the project area. (Figure 4.1)
